The Discovery and Assessment of Lead in a Modern Residential Plumbing System

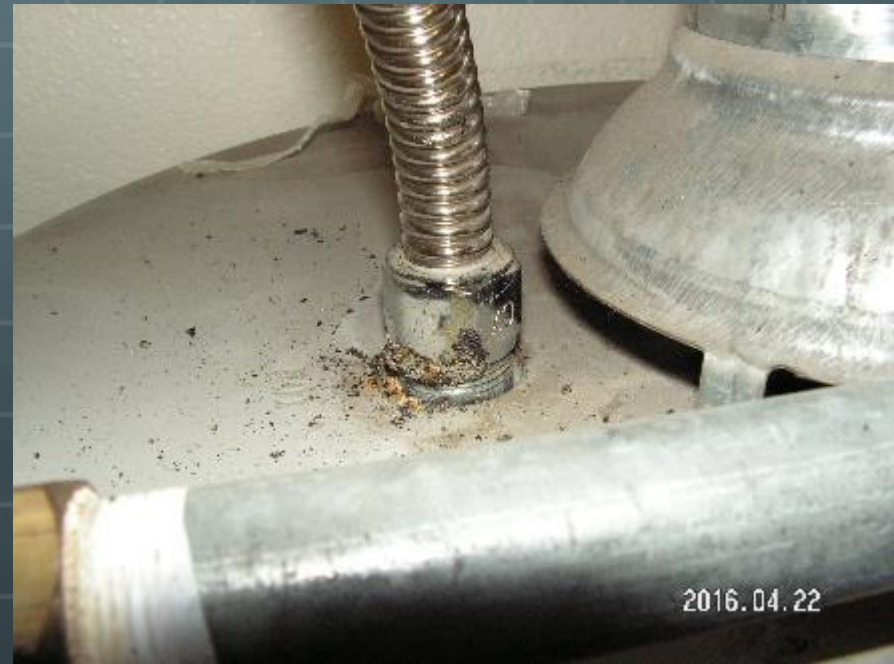
- Qualitative-Noted deteriorated rubber gasket on HWH-out
- Quantitative-All results unremarkable except:
 - HWH sample revealed lead at 200 ug/l-in excess of EPAs *Lead & Copper Rule Action Level* of 15 ug/l (aka MCL)

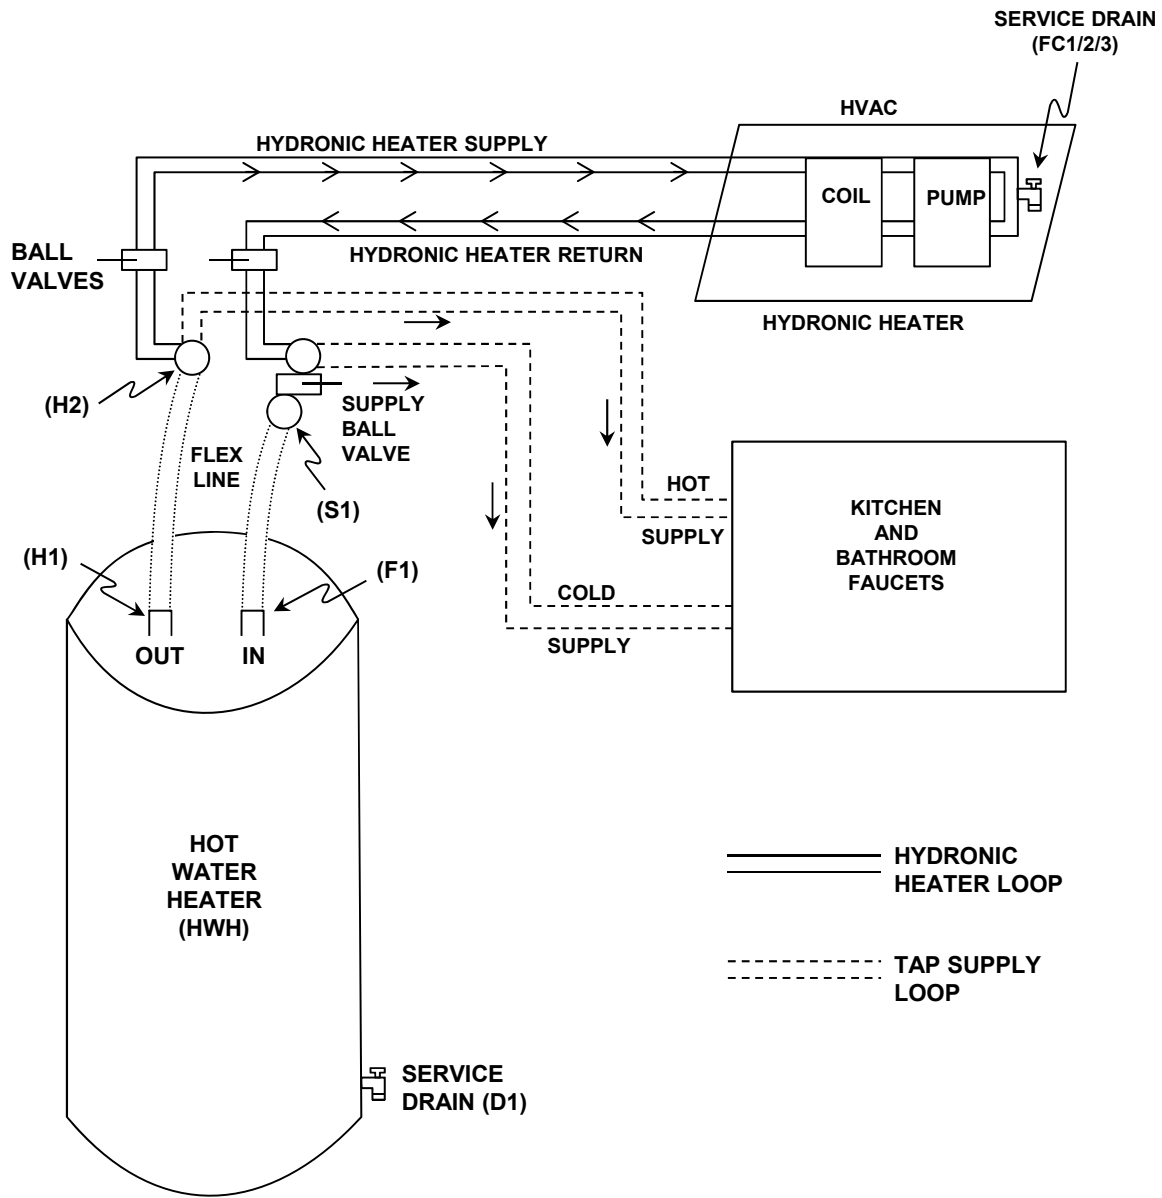
- Reanalysis of HWH water sample using 200.8 revealed lead at 286 ug/l (>prior)-Elevated lead confirmed
- Qualitative assessment of complex/unit
 - Municipal supply/typical copper plumbing
 - Rubber gaskets deteriorating at HWH-Smearing duplicated
 - Hydronic system shares HWH-Aside from HWH, hydronic system independent (=“Loop”)

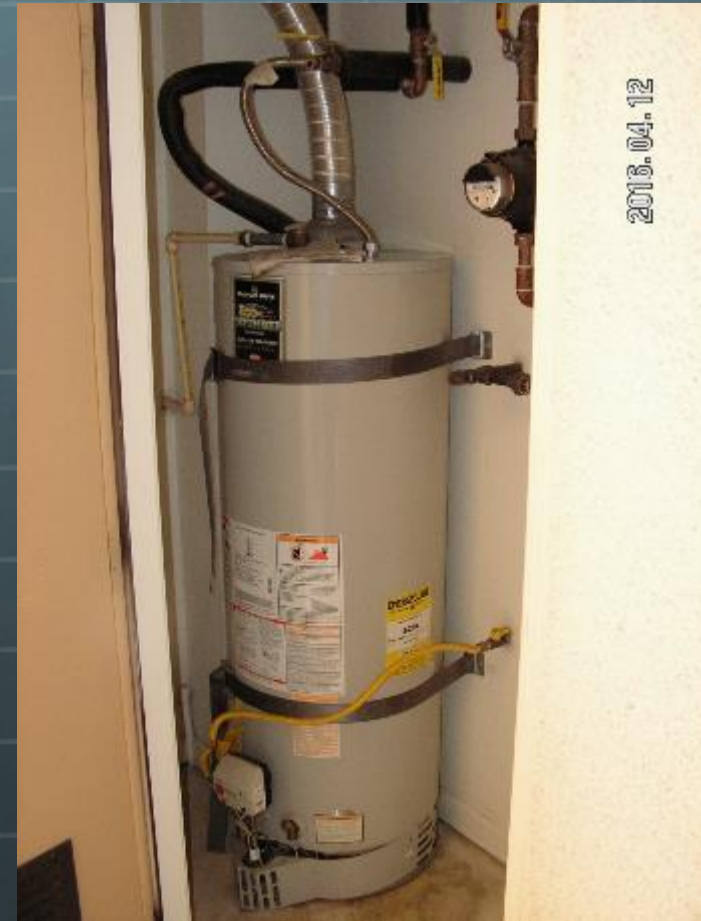
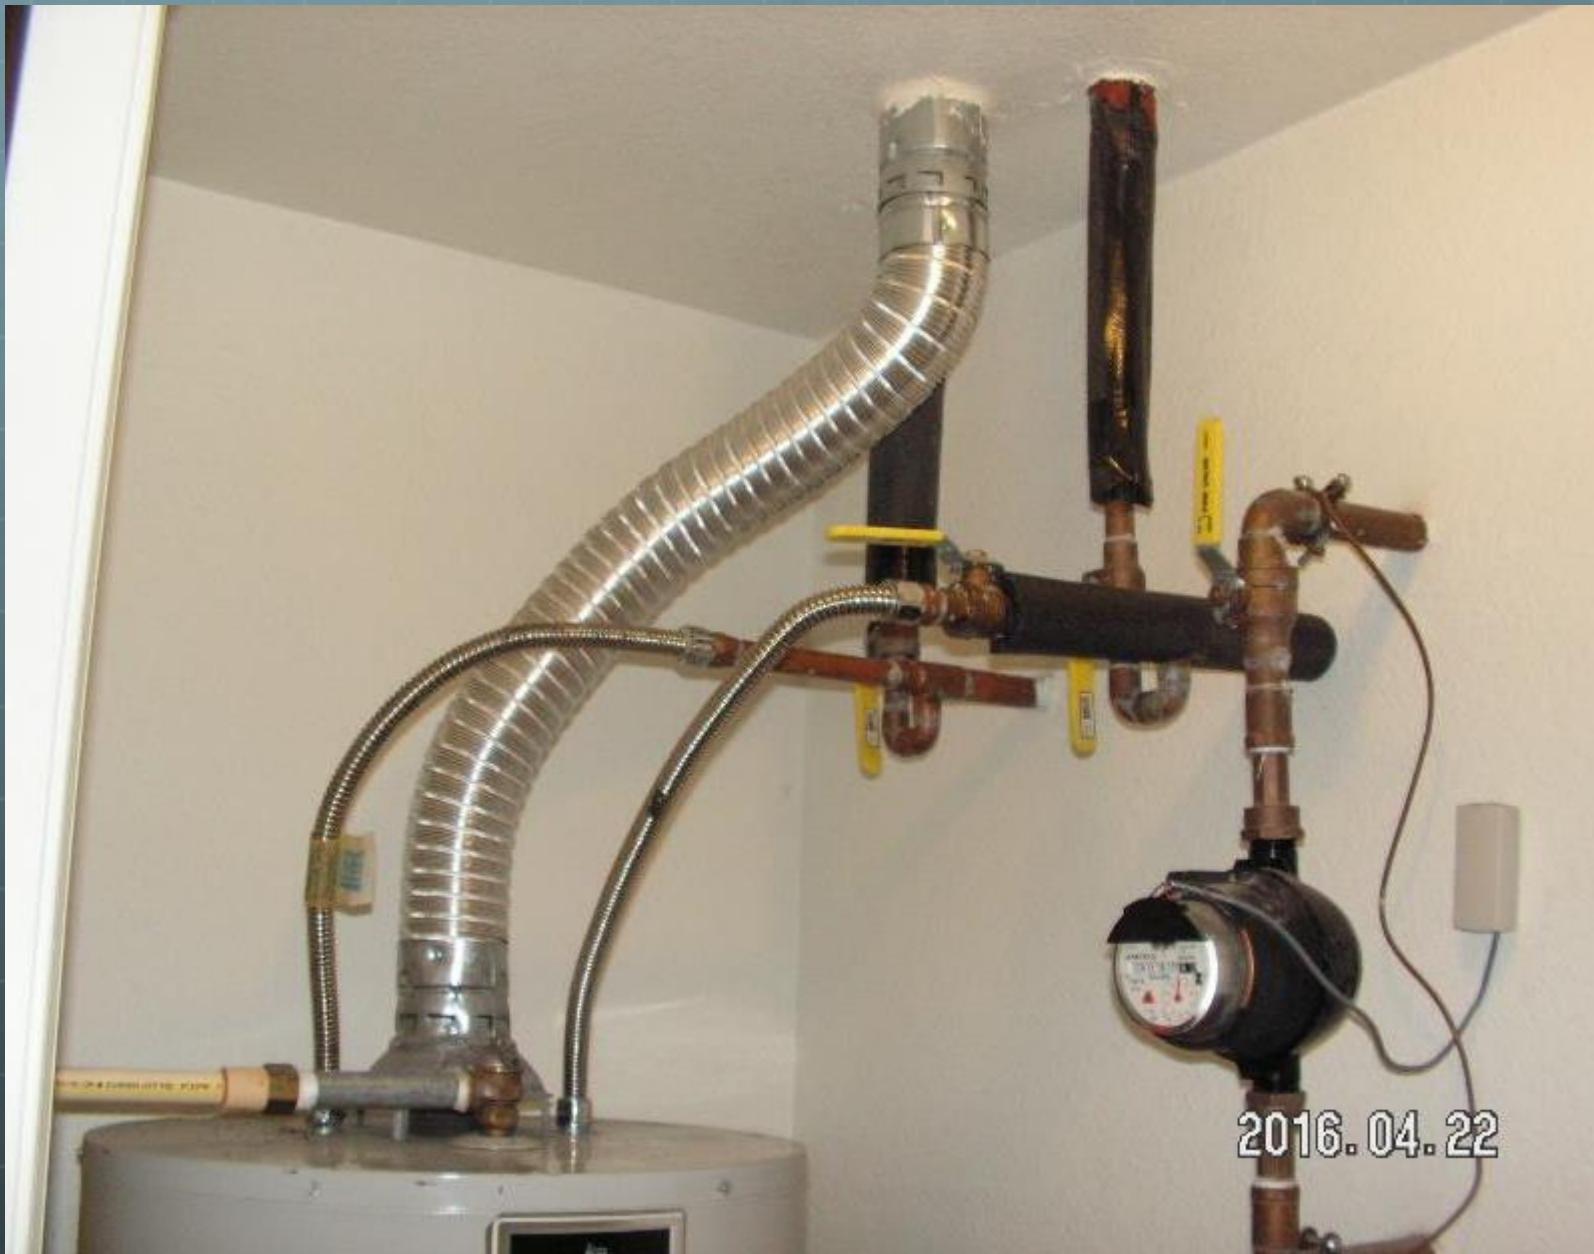
- Quantitative assessment of water-15 units
 - Scope influenced by Qualitative findings (i.e., “source isolation” objective)
 - Taps (146 samples)-Kitch/BA, Hot/Cold, Initial draw/Flushed
 - Hydronic “Loop” (73 samples)
 - HWH
 - Service drain
 - Cold supply in (Hydronic loop out)
 - Pre flex line
 - Post flex line

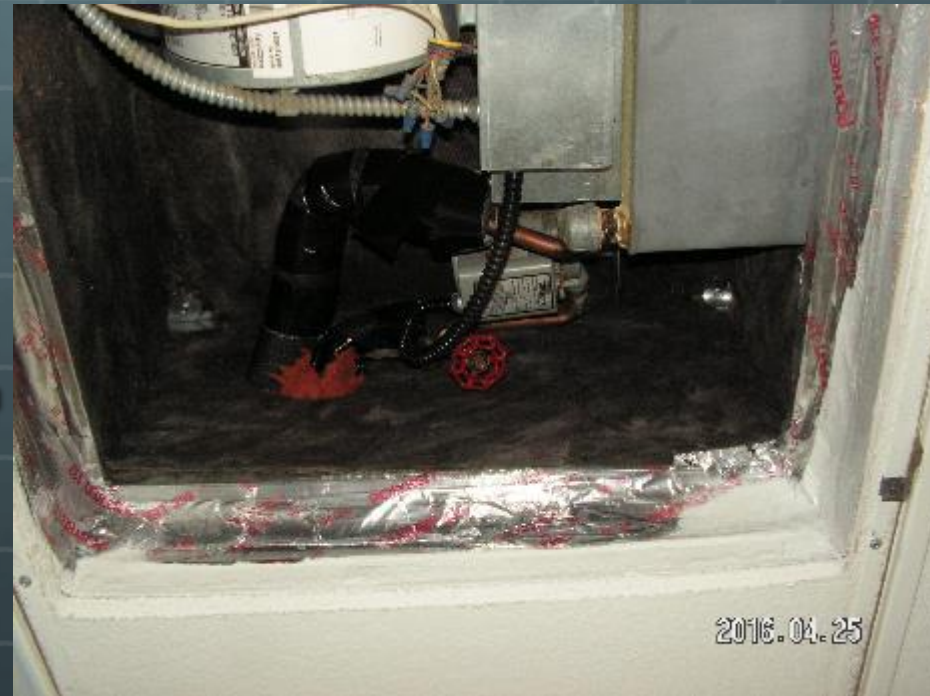
- Quantitative assessment of water (Cont.)
 - Scope ... (Cont.)
 - Hydronic “Loop” (73 samples) (cont.):
 - Hydronic Heater
 - Service drain:
 - First Draw/Pre-flush
 - Flushed-Idle heater
 - Flushed-Operating heater
 - Municipal (1 sample)
 - Exterior spigot
